NINA in the ECORESP-C project

ECORESP-C seminar
11.4.2024

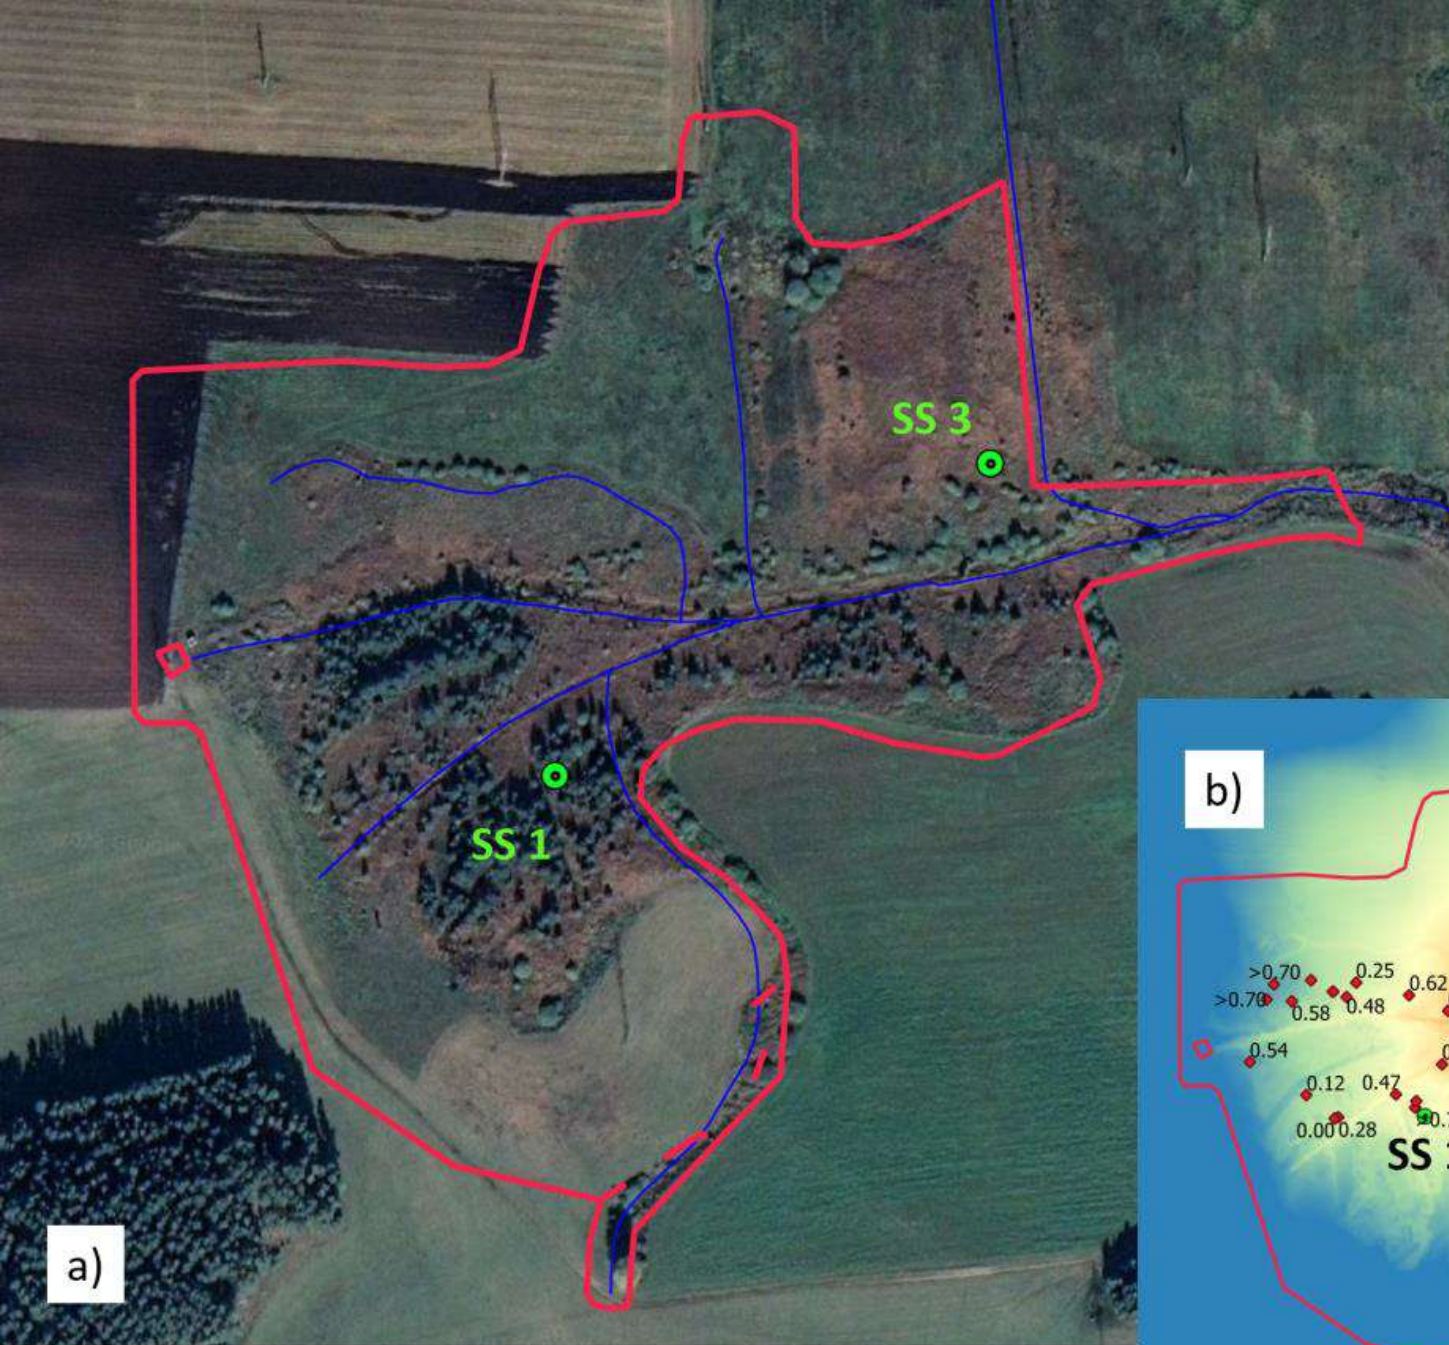
Spišskoteplické slatiny, northern site:

a) aerial image with suggested monitoring locations

b) Digital Terrain Model with observed peat thickness suggested monitoring locations.

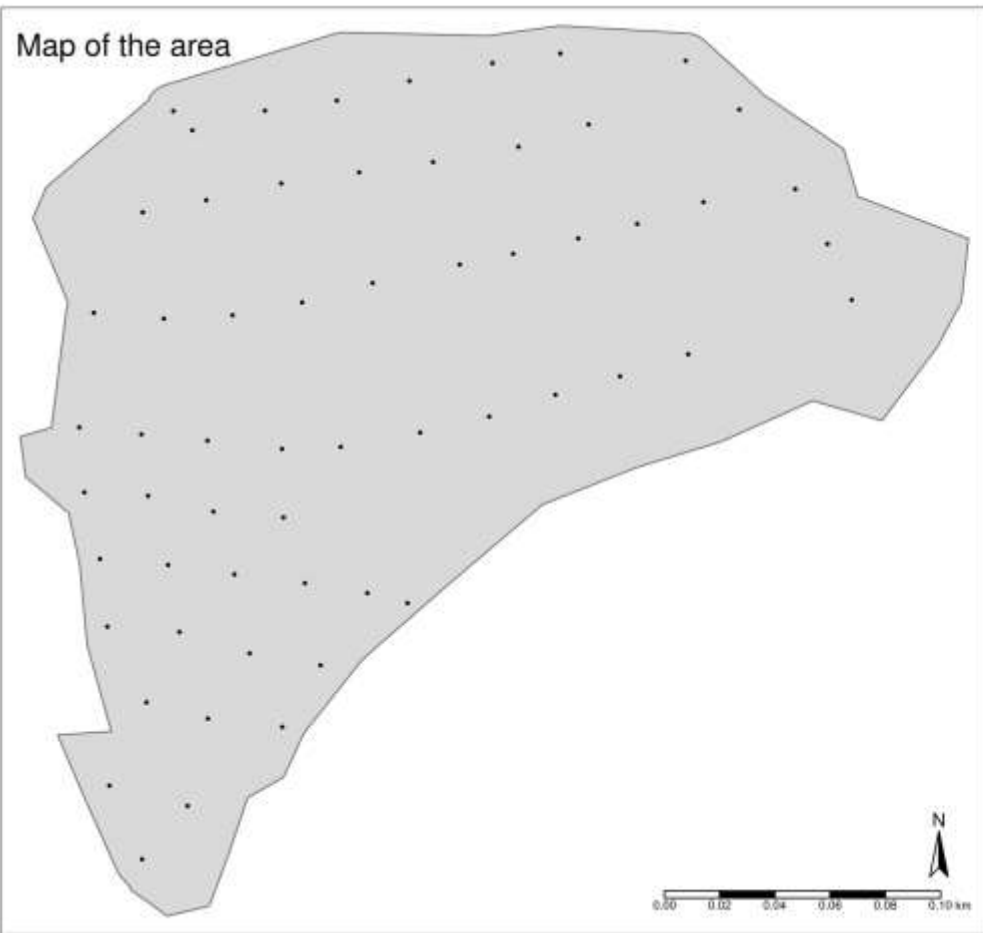
Carbon stock in the bog at Klinské rašelinisko

- 6719 tonn C using Loisel et al. (2014)

- 7458 tonn C using our samples

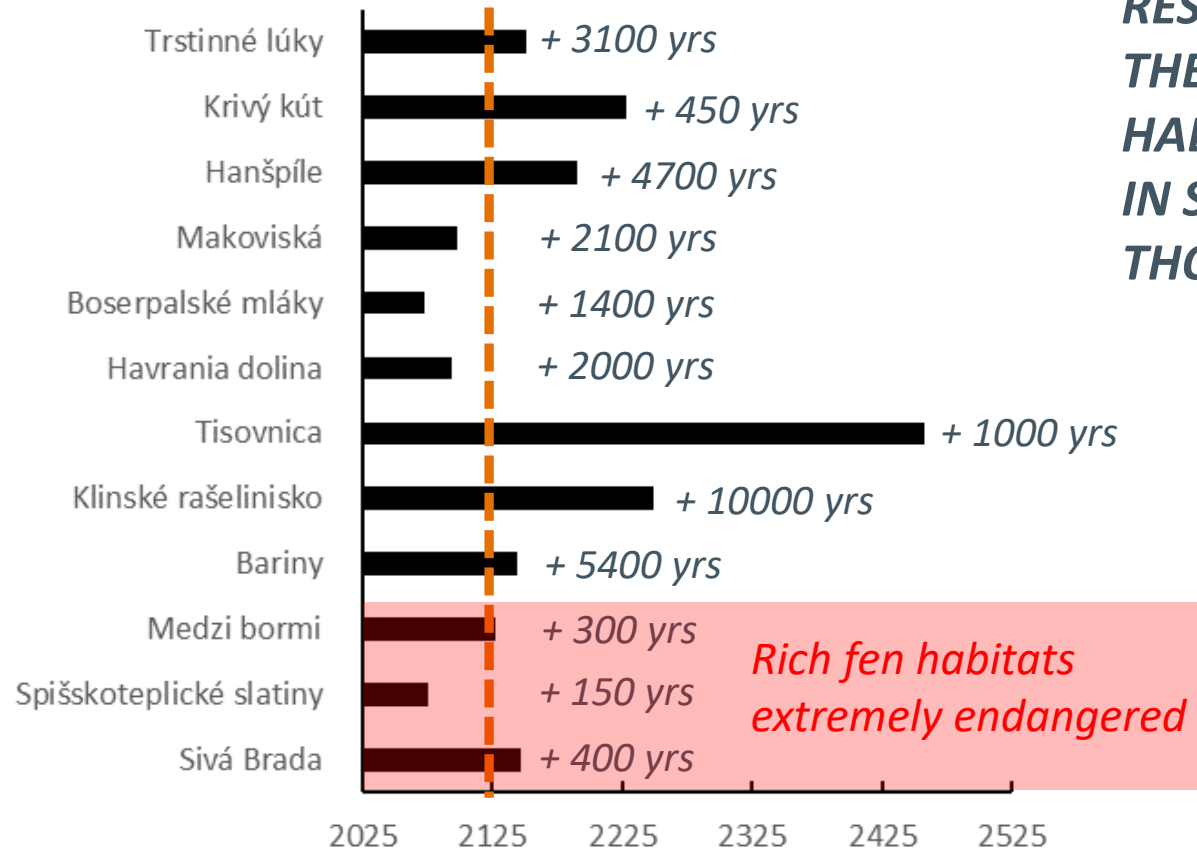
RESTORATION MAY EXTEND THE LIFETIME OF PEATLAND HABITATS BY HUNDREDS, IN SOME CASES EVEN THOUSANDS OF YEARS

Theoretical time for complete loss of C stock calculated with C densities measured *in situ* in ECORESP project and IPCC tier 1 emission factors for drained and restored peatlands of temperate climate zone.

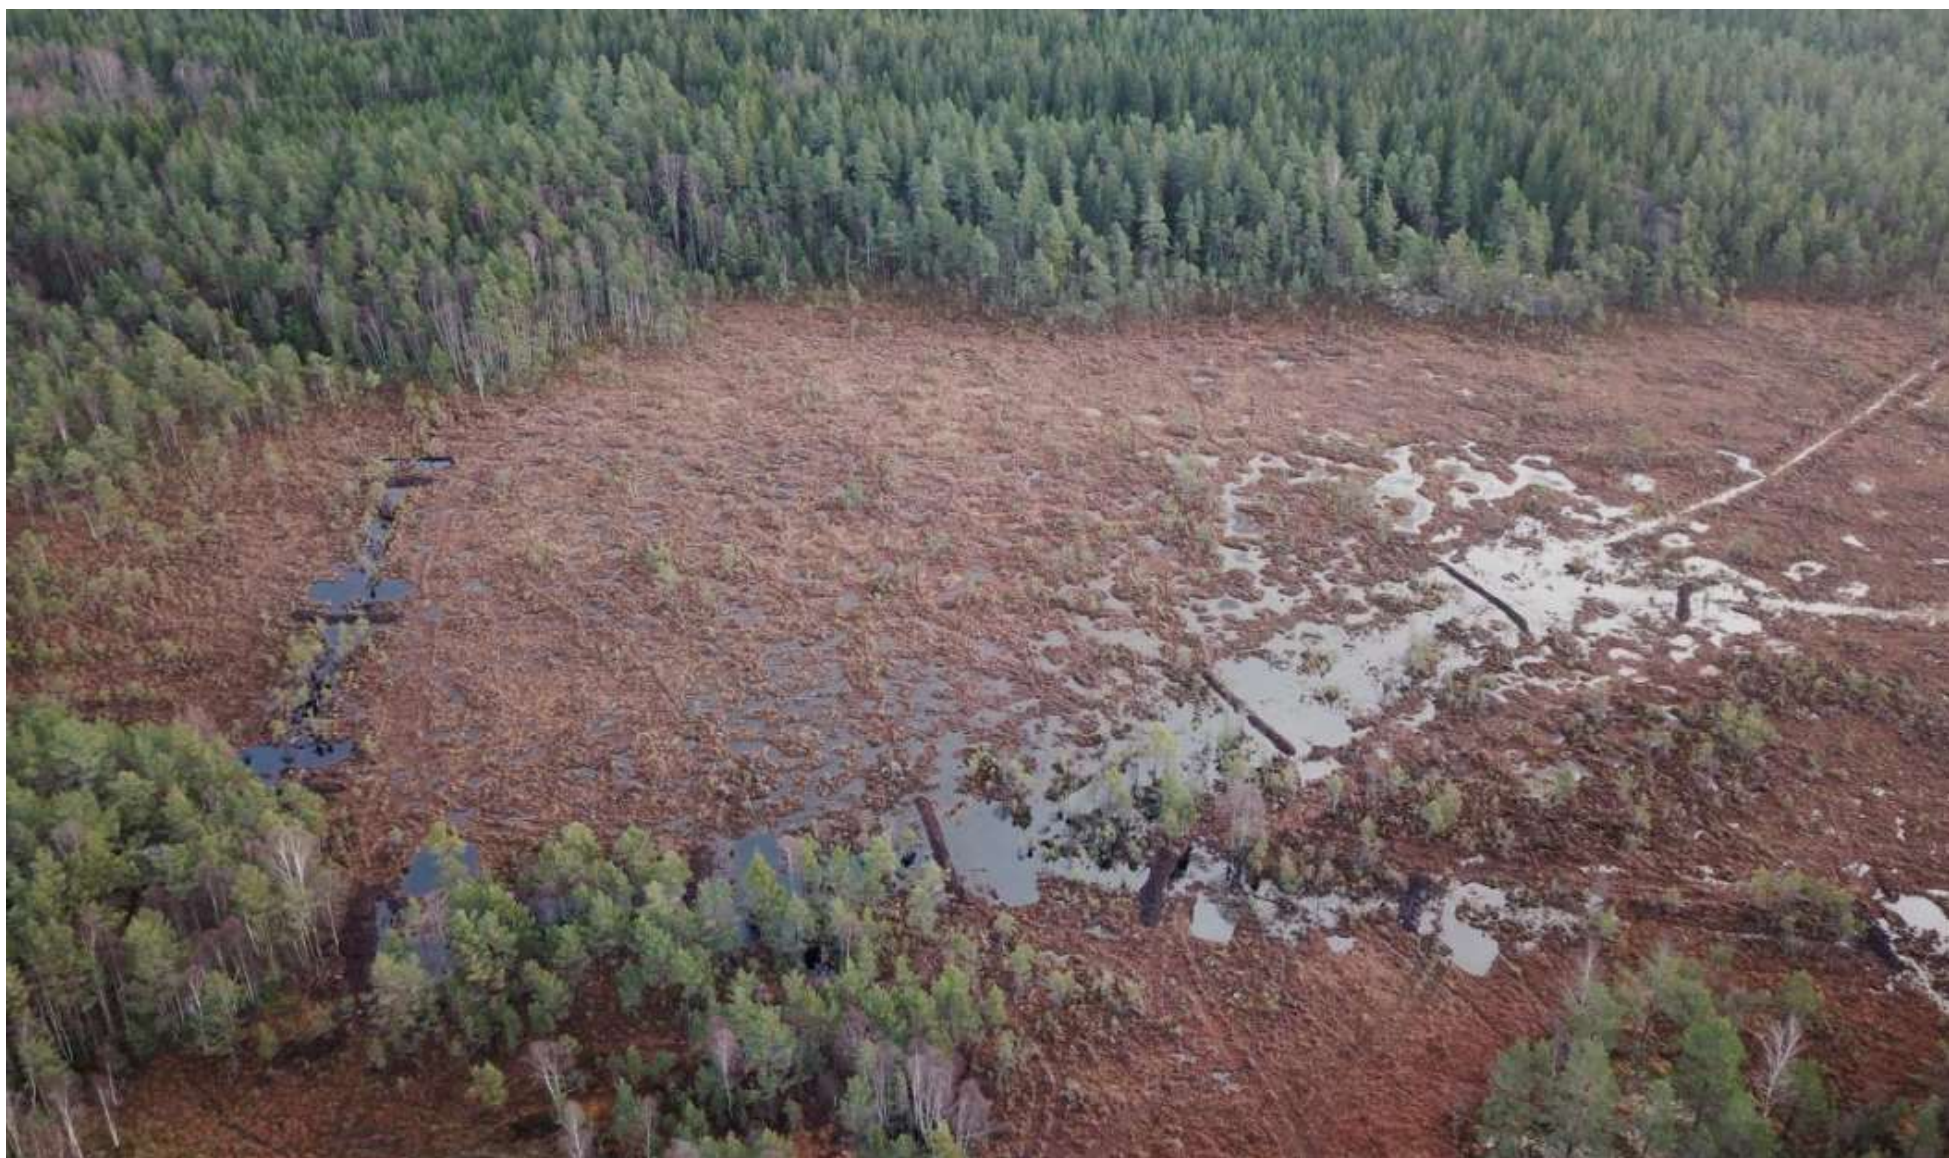
Bog and bog woodland under restoration at Brattås Nature reserve in Norway. Restoring the natural levels flow of water at the site is almost always the primary requirement for restoration.

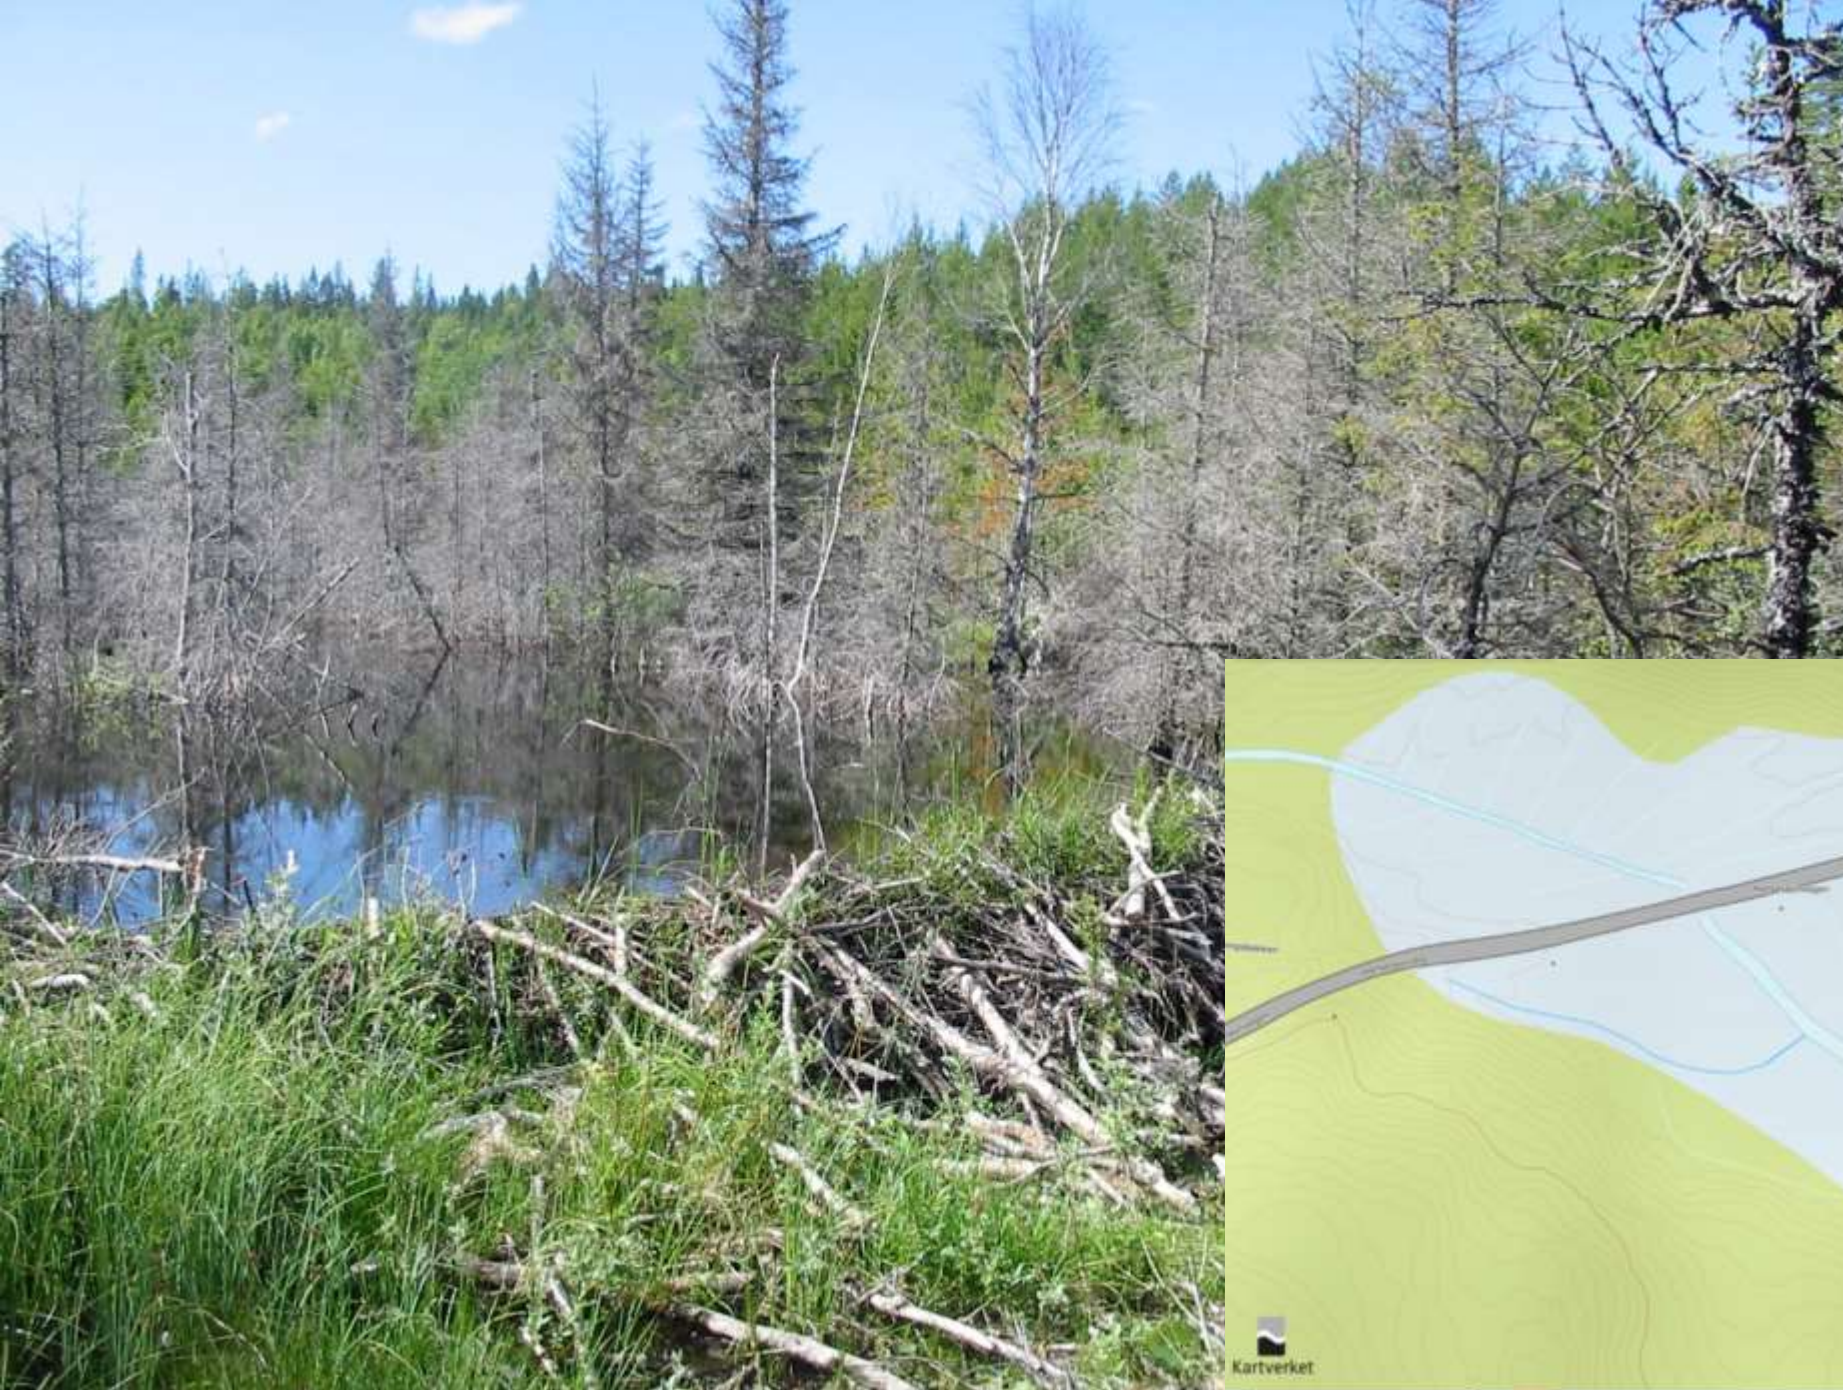
Beaver dam on a ditched and canalised stream in drained forest bog, Trondheim Bymarka, Norway.

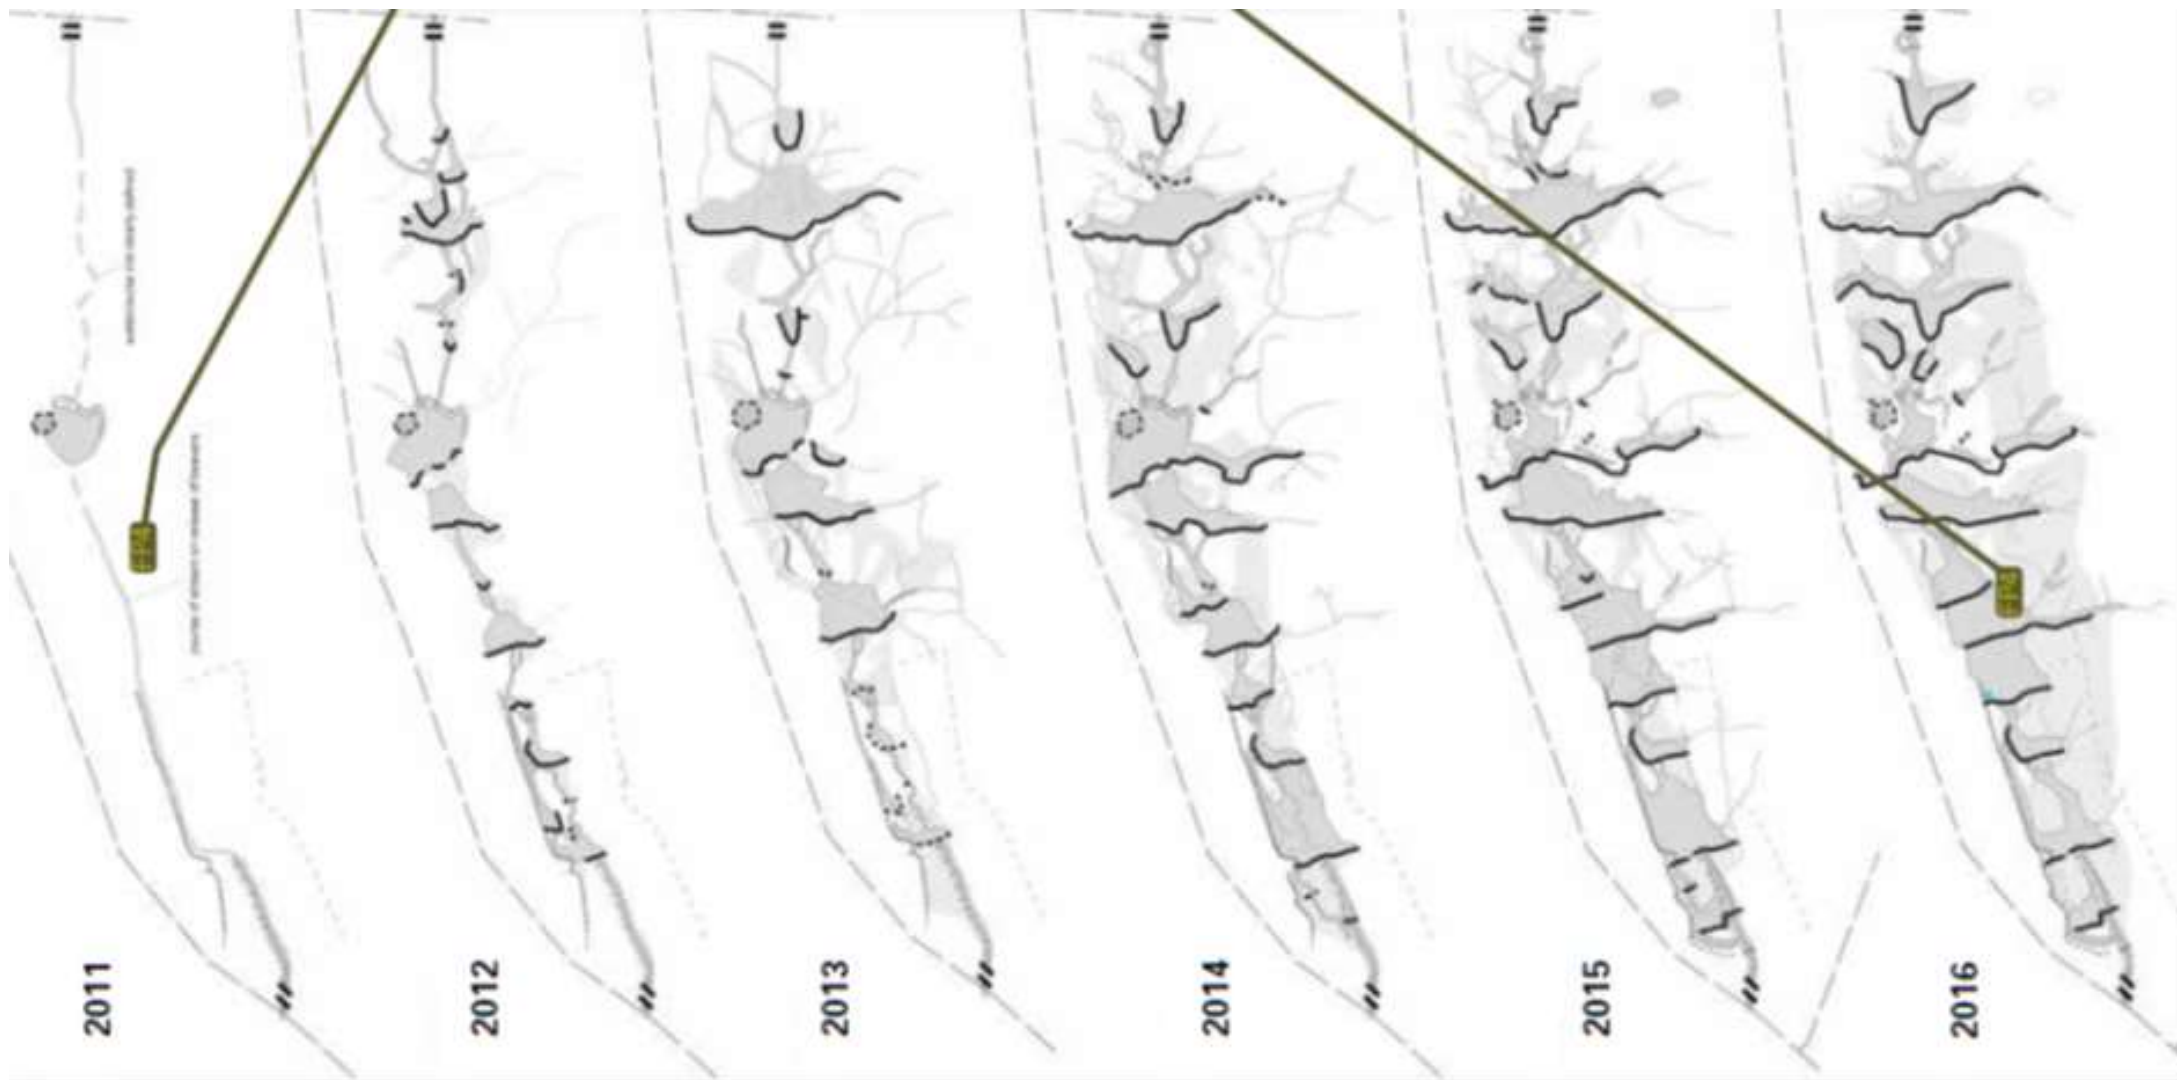
Development of a small stream converted to a drainage ditch, often dry in summer, into a complex restored bog woodland, as a result of beaver activity. Grey indicates surface water, black beaver dams. Source: Devon Wildlife Trust 2017.

- Bog woodland management experience in Scandinavia indicates the primary importance of restoring natural water flow regimes at a site. Often this is now done 'naturally' by the expanding beaver population. Their damming activities can be mimicked in places that beavers have not yet colonised.

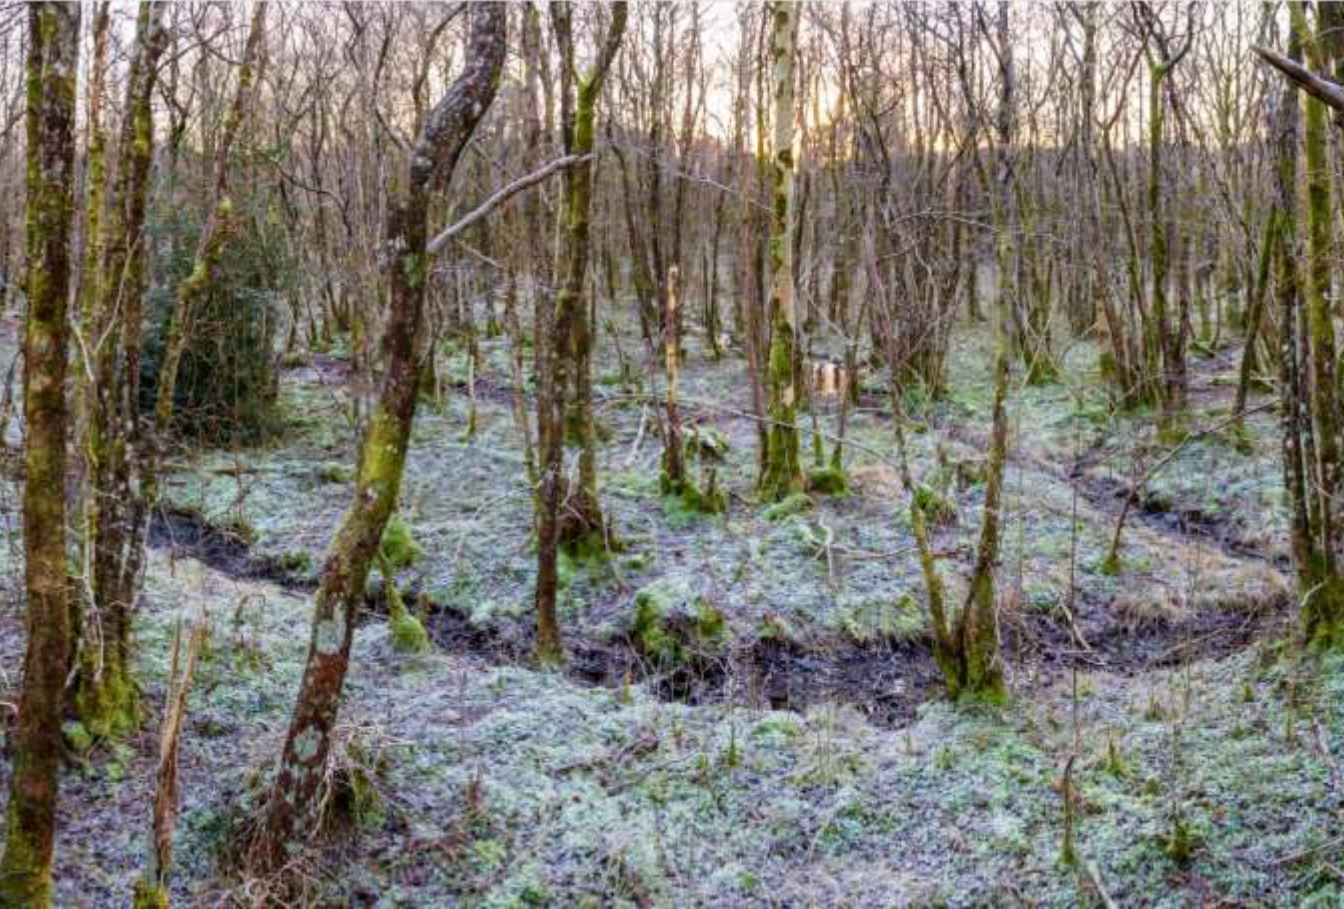
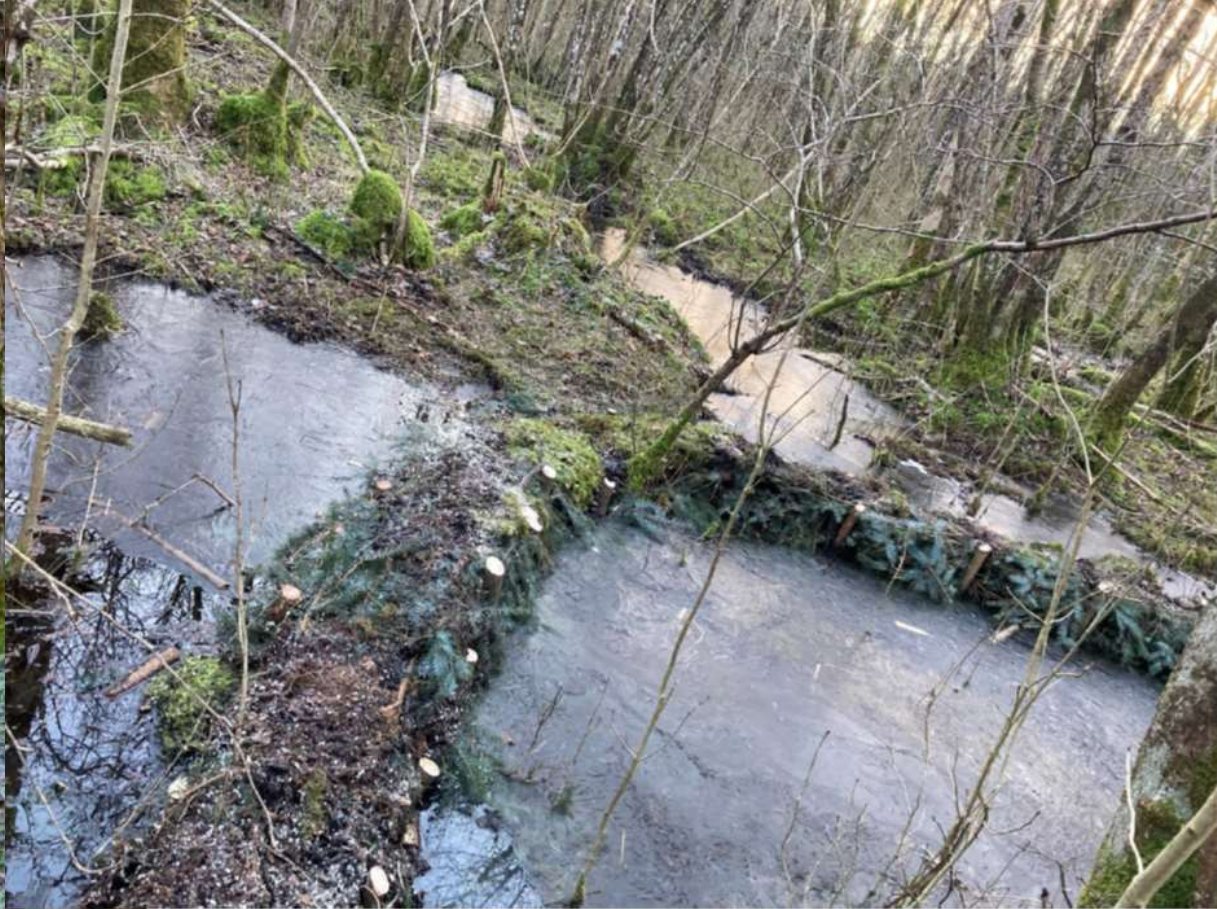
Lundarsøyla, SW Norway. Former bog woodland dried out by Drainage ditches. There are no beavers in the area as yet...

...but their effects can be mimicked by building artificial dams from local materials, in this case unwanted invasive dry-ground tree species as the frame, infilled with wet peat

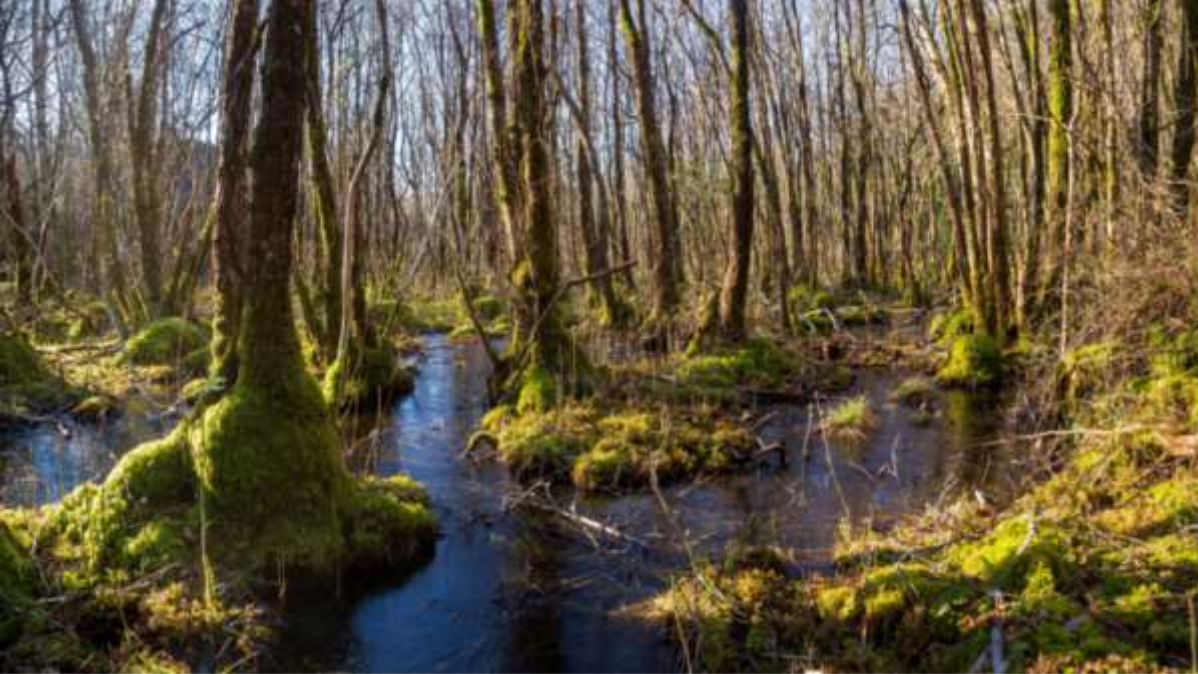
Lundarsøyla restored – note small dam, now overgrown, in lower picture.

Natural water flows across the site have been restored, the bog woodland and its Sphagnum understory reestablished, and peat formation resumed.
